**Flood Control Project Maintenance
Levee Inspections**
LMA District Cover Sheet
Spring 2017 Levee Inspection Results

Sacramento Maintenance Yard Putah Creek

Spring 2017 Levee Inspection Results

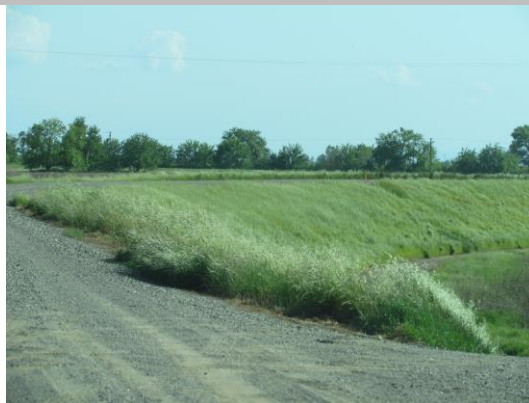
Photo 1 of 1 : SP_2017_ST0007_282_36_20170509_00059.jpg

LM Start	0.01	Rating **	U	Issue No.	36
LM End	8.31	Issue Type +	Ma	Location *	LS
Category	Earthen Levee			GPS Latitude/Longitude	
				Start	End
Item	Vegetation			38.523537 °	38.521547 °
				-121.631462 °	-121.776958 °
DWR ID	DWR_ST0007_01_s_2017_36				
Comment Code					
V1 : Control annual grass and weeds on the levee slopes and easements.					
Inspector Comment					
Due to the wet winter months weeds has been encouraged to grow out of control. Control the annual grasses and weeds on the slope and levee toe.

Looking upstream from levee mile 0.01 landside shoulder. Unwanted tall weeds present on the levee slope and shoulder.

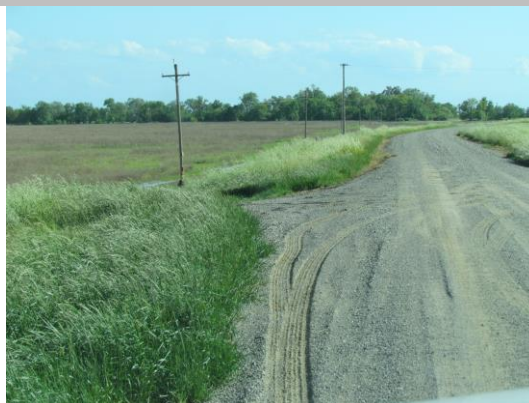
Photo 1 of 1 : SP_2017_ST0007_282_37_20170509_00060.jpg

LM Start	0.01	Rating **	U	Issue No.	37
LM End	8.31	Issue Type +	Ma	Location *	WS
Category	Earthen Levee			GPS Latitude/Longitude	
				Start	End
Item	Vegetation			38.523537 °	38.521547 °
				-121.631462 °	-121.776960 °
DWR ID	DWR_ST0007_01_s_2017_37				
Comment Code					
V1 : Control annual grass and weeds on the levee slopes and easements.					
Inspector Comment					
Control the tall annual weds and grasses on the levee section.

Looking upstream from levee mile 0.01 waterside levee shoulder. Tall weeds present on the levee section.

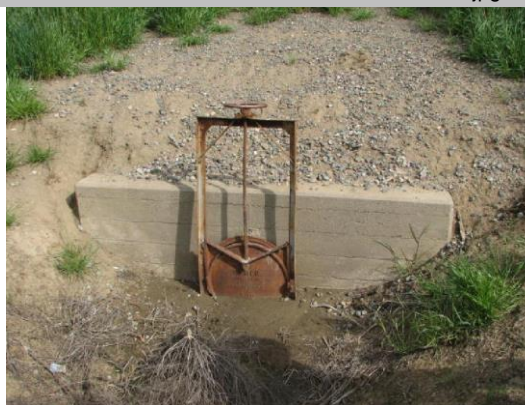
Photo 1 of 3 : UCIP_SP_2017_33408_60493.jpg

LM Start	0.58	Rating **	A/W	Issue No.	39
LM End	0.58	Issue Type +	Ma	Location *	LS
Category	Supplemental			GPS Latitude/Longitude	
				Start	End
Item	DWR UCIP LMA Responsibility			38.519660 °	38.519660 °
				-121.638820 °	-121.638820 °
DWR ID					
Comment Code					
Inspector Comment					
FS_ID:33408 DS_ID:488 EP_NO: 10261 Repair Type: No Action Needed Crossing Status: Found UCIP Comments: FIELD_STRUCT_DESC: 24-inch drainage pipe of unknown material through the levee, 12.5 feet below the crown. Slide gate is located on the waterside (WS) end. Concrete headwall is located on the WS. (24-inch pipe authorized under Automatic Board Order (ABO) issued as Permit No. 10261, 1974 - Tufts) [Additional Reference(s): DWR Levee Log, 1981 and 2005. USACE Sacramento O&M Manual Unit 119, December 1952, (Station XX+XX)] FS Date: 4/10/2014 2:49:52 PM

WS slide gate and headwall

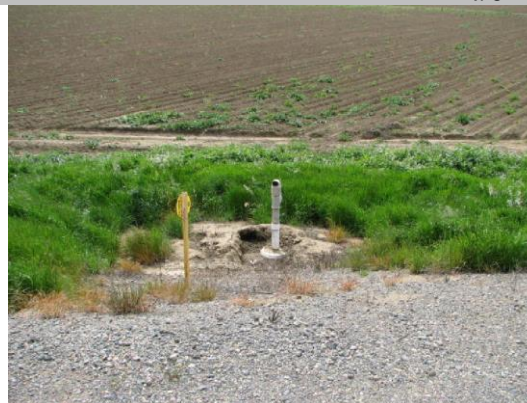
Photo 1 of 3 : UCIP_SP_2017_48122_60481.jpg

FS_ID:48122
DS_ID:489
EP_NO: 10262
Repair Type: Non-Urgent
Crossing Status: Found
UCIP Comments: Pump is disconnected from pipe and could cause backflow at highwater event. Can't see size of pipe sleeved through 24-inch pipe.
FIELD_STRUCT_DESC: 18-inch steel irrigation pipe (field verified not 16-inch) sleeved through existing 24-inch drainage steel pipe through levee, 12.5 feet below the crown. Annular space sealed at both the waterside (WS) and landside (LS) ends. Concrete headwalls are located on both the WS and LS ends. PVC sleeved December of 2007 (unknown source). (16-inch pipe sleeved through 24-inch pipe authorized under Automatic Board Order (ABO) issued as Permit No. 10262, 1974 - Wells Fargo Bank, Trustee for S.H. Cowell Foundation)
[Additional Reference(s): DWR Levee Log, March 2007. USACE Sacramento O&M Manual 119, December 1952]
FS Date: 4/10/2014 2:48:00 PM

WS vent

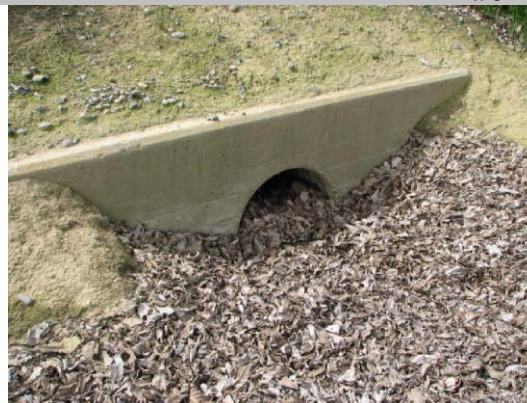
Photo 2 of 2 : UCIP_SP_2017_33394_60457.jpg

Item	DWR UCIP LMA Responsibility			38.517580 °		38.517580 °
				-121.676820 °		-121.676820 °
DWR ID						
Comment Code						
Inspector Comment						
FS_ID:33394 DS_ID:492 EP_NO: 10262 Repair Type: No Action Needed Crossing Status: Found UCIP Comments: FIELD_STRUCT_DESC: 24-inch drainage pipe of unknown material through levee, 13 feet below crown. Slide gate is located on the waterside (WS) end. Concrete headwalls are located on both the waterside (WS) and landside (LS). (24-inch pipe authorized under Automatic Board Order (ABO) issued as Permit No. 10262, 1974 - Wells Fargo Bank, Trustee for S.H. Cowell Foundation) [Additional Reference(s): DWR Levee Log, 1981 and 2005. USACE Sacramento O&M Manual Unit 119, December 1952, (Station XX+XX)] FS Date: 4/10/2014 2:43:44 PM

LS headwall

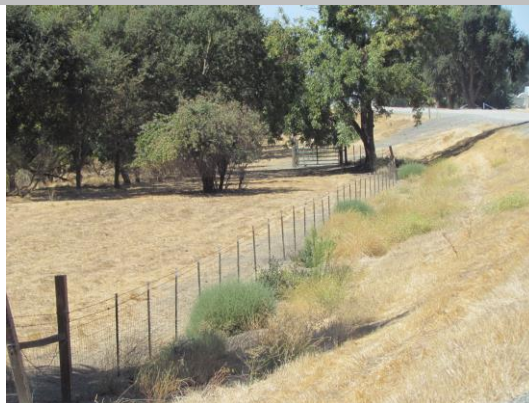
Photo 1 of 1 : SP_2017_ST0007_282_4_20170404_00001.jpg

LM Start	3.25	Rating **	M	Issue No.	4
LM End	3.43	Issue Type +	En	Location *	WS
Category	Earthen Levee			GPS Latitude/Longitude	
				Start	End
Item	Encroachments			38.519831 °	38.520011 °
				-121.686263 °	-121.689552 °
DWR ID	DWR_ST0007_01_s_2013_4				
Comment Code					
FE : Fence					
Inspector Comment					
No permit for this wire fence waterside levee slope.

Wire fence within the 10-foot easement waterside levee toe.

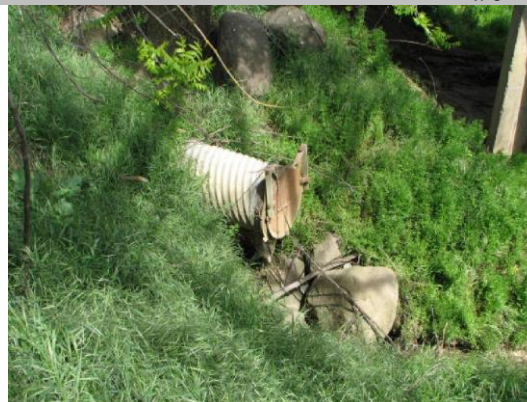
Photo 3 of 3 : UCIP_SP_2017_33381_60440.jpg

Item	DWR UCIP LMA Responsibility			38.519790 °		38.519790 °
				-121.695450 °		-121.695450 °
DWR ID						
Comment Code						
Inspector Comment						
FS_ID:33381						
DS_ID:496						
EP_NO: 10251						
Repair Type: No Action Needed						
Crossing Status: Found						
UCIP Comments:						
FIELD_STRUCT_DESC: 24-inch corrugated metal drainage pipe through levee, 15 feet below the crown. Two metal cutoff walls were installed through the levee. A T-post and T-handle are located on the landside (LS) toe. The outfall structure and flap gate are located on the west side of bridge, waterside (WS). (24-inch pipe authorized under Automatic Board Order (ABO) issued as Permit No. 10251, 1974 - F.M.C. Corp.) [Additional Reference(s): DWR Levee Log, 1981 and 2005. USACE Sacramento O&M Manual Unit 119, December 1952, (Station XX+XX)]						
FS Date: 4/10/2014 2:40:30 PM

Outfall at creek with flap gate.

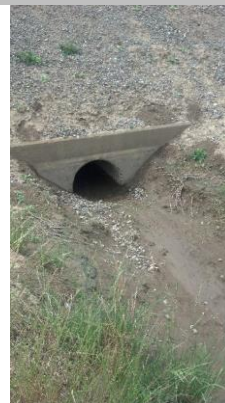
Photo 1 of 3 : UCIP_SP_2017_33371_60418.jpg

LM Start	5.28	Rating **	A/W	Issue No.	47
LM End	5.28	Issue Type +	Ma	Location *	WS
Category	Supplemental			GPS Latitude/Longitude	
				Start	End
Item	DWR UCIP LMA Responsibility			38.518022 °	38.518022 °
				-121.722521 °	-121.722521 °
DWR ID					
Comment Code					
Inspector Comment					
FS_ID:33371 DS_ID:500 EP_NO: 10256 Repair Type: No Action Needed Crossing Status: Found UCIP Comments: Debris removed. See picture FIELD_STRUCT_DESC: 24-inch drainpipe through the levee 15.0 feet below the crown. Slide gate on waterward end. Concrete headwall on landward end. (ABO No. 10256 - Lederer FS Date: 4/10/2014 2:37:39 PM

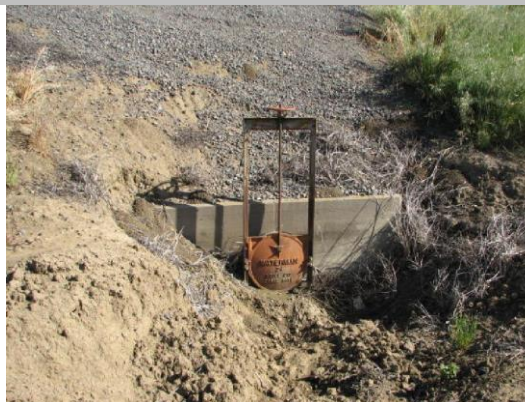
Photo 2 of 3 : UCIP_SP_2017_33371_60416.jpg

WS slide gate

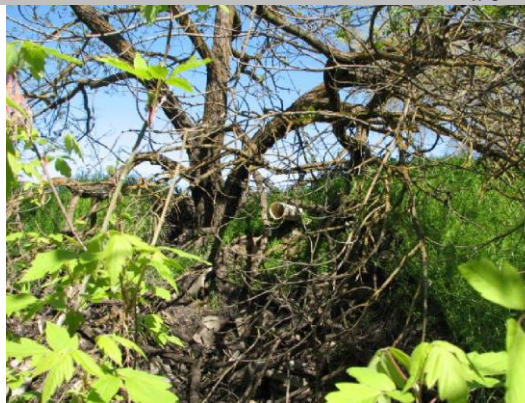
Photo 2 of 3 : UCIP_SP_2017_33367_60408.jpg

LM Start	5.56	Rating **	M	Issue No.	50 (cont)	
LM End	5.56	Issue Type +	En	Location *	WS	
Category	Supplemental			GPS Latitude/Longitude		
				Start	End	
Item	DWR UCIP Field Study			38.518250 °	38.518250 °	
				-121.727685 °	-121.727685 °	
DWR ID						
Comment Code						
Inspector Comment						
FS_ID:33367						
DS_ID:590						
EP_NO: 14140						
Repair Type: Non-Urgent						
Crossing Status: Found						
UCIP Comments: Air vent broken off on water side shoulder. Also, no flap gate or other positive closure device on either side of levee. No requirement in permit for applicant to install positive closure device, but it may be necessary if maintenance or upgrade is performed on pipe.						
FIELD_STRUCT_DESC: 6" PVC pipe though levee 16' FBC. 24" stand pipe with pump on land side. Pipe outfalls at creek with rip-rap.						
FS Date: 4/10/2014 2:35:30 PM

WS outfall at creek bank

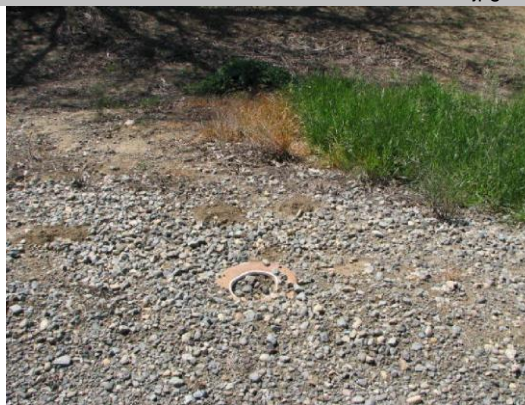
Photo 3 of 3 : UCIP_SP_2017_33367_60407.jpg

WS shoulder broken air vent

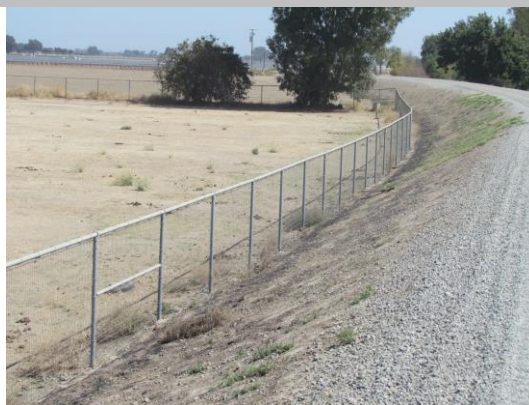
Photo 2 of 2 : SP_2017_ST0007_282_5_20170404_00003.jpg

LM Start	6.63	Rating **	M	Issue No.	5
LM End	6.71	Issue Type +	En	Location *	LS
Category	Earthen Levee			GPS Latitude/Longitude	
				Start	End
Item	Encroachments			38.517746 °	38.517647 °
				-121.747220 °	-121.748679 °
DWR ID	DWR_ST0007_01_s_2012_5				
Comment Code					
FE : Fence					
Inspector Comment					
This fence has been in the area for many years. Levee mile 6.70-6.84 landside within10-foot of easement. No new photo ws taken.

Levee mile 6.63-6.71 landside levee toe.

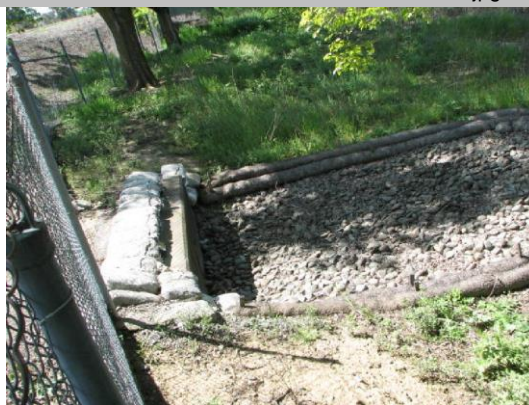
Photo 3 of 3 : UCIP_SP_2017_33343_60358.jpg

LS headwall

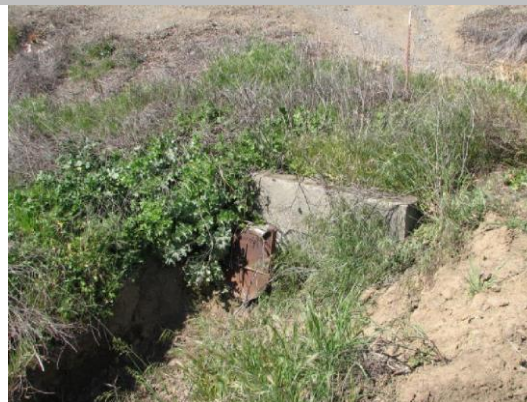
Photo 2 of 2 : UCIP_SP_2017_42952_60352.jpg

WS Flapgate

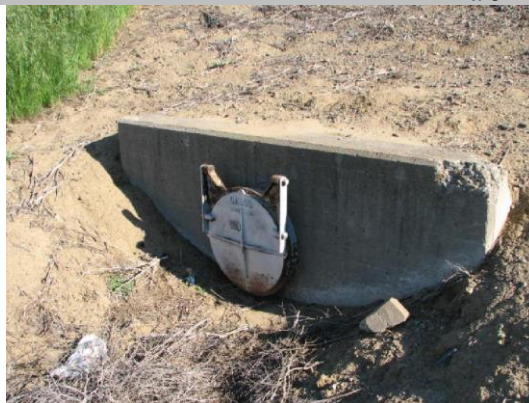
Photo 1 of 2 : UCIP_SP_2017_41353_60345.jpg

WS Flap Gate and headwall.

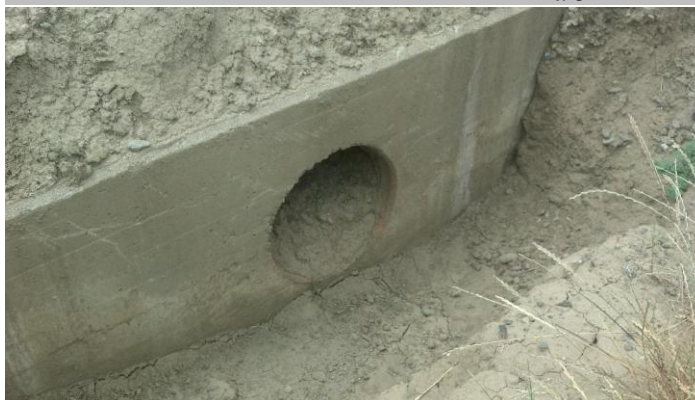
Photo 1 of 3 : UCIP_SP_2017_33328_60329.jpg

LM Start	8.28	Rating **	A/W	Issue No.	61
LM End	8.28	Issue Type +	Ma	Location *	WS
Category	Supplemental		GPS Latitude/Longitude		
			Start	End	
Item	DWR UCIP LMA Responsibility		38.521246 °	38.521246 °	
			-121.776434 °	-121.776434 °	
DWR ID					
Comment Code					
Inspector Comment					
FS_ID:33328 DS_ID:520 EP_NO: 10247 Repair Type: No Action Needed Crossing Status: Found UCIP Comments: Cleaned inlet and outlets. Owner of pipe may need to clean pipe FIELD_STRUCT_DESC: 4-inch drainpipe through the levee 8.0 feet below the crown. Slide gate on waterward end. (ABO No. 10247 U.C.D.) FS Date: 4/10/2014 2:23:46 PM

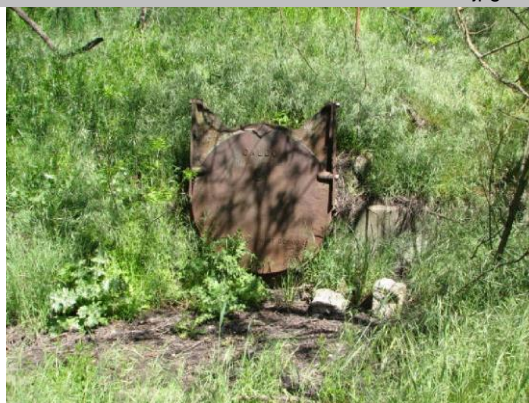
Photo 3 of 3 : UCIP_SP_2017_41129_60300.jpg

WS flap gate

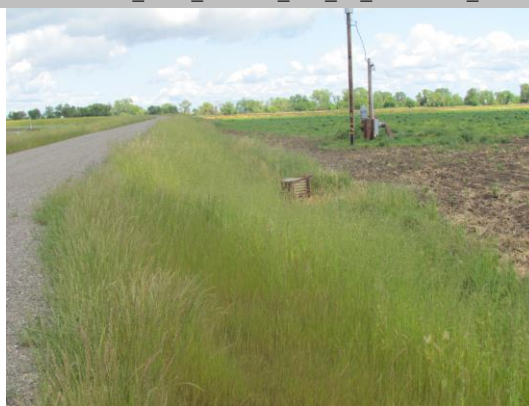
Photo 1 of 1 : SP_2017_ST0007_283_43_20170510_00057.jpg

LM Start	0.01	Rating **	U	Issue No.	43
LM End	2.78	Issue Type +	Ma	Location *	WS
Category	Earthen Levee			GPS Latitude/Longitude	
				Start	End
Item	Vegetation			38.504772 °	38.514920 °
				-121.663177 °	-121.706327 °
DWR ID	DWR_ST0007_02_s_2017_43				
Comment Code					
V1 : Control annual grass and weeds on the levee slopes and easements.					
Inspector Comment					
Control annual grasses and weeds from the levee slope and easement.

Looking upstream from levee mile 0.01 Unit 2 waterside slope.

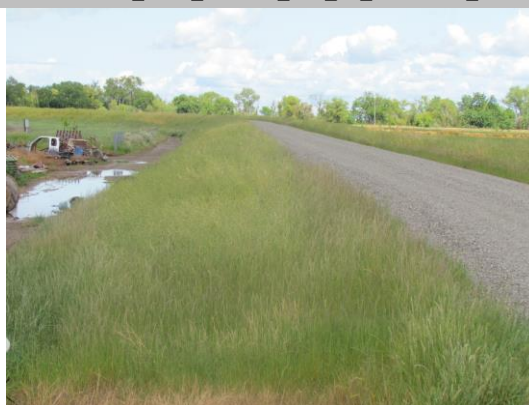
Photo 1 of 1 : SP_2017_ST0007_283_42_20170510_00058.jpg

LM Start	0.01	Rating **	U	Issue No.	42
LM End	5.57	Issue Type +	Ma	Location *	LS
Category	Earthen Levee			GPS Latitude/Longitude	
				Start	End
Item	Vegetation			38.504772 °	38.515593 °
				-121.663177 °	-121.757437 °
DWR ID	DWR_ST0007_02_s_2017_42				
Comment Code					
V1 : Control annual grass and weeds on the levee slopes and easements.					
Inspector Comment					
Control the annual grasses and weeds on the slope and toe.

Looking upstream from levee mile 0.01 landside shoulder at the weed growth on the landward slope.

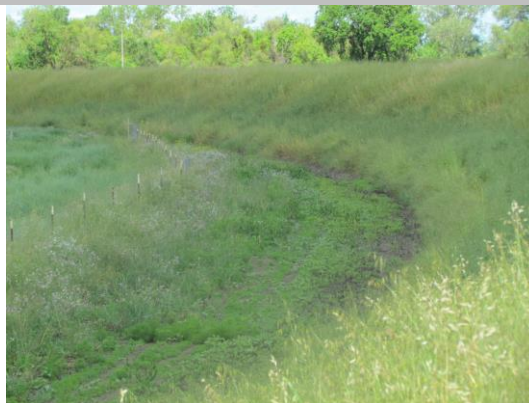
Photo 1 of 1 : SP_2017_ST0007_283_3_20170510_00059.jpg

LM Start	0.18	Rating **	U	Issue No.	3
LM End	0.31	Issue Type +	En	Location *	LS
Category	Earthen Levee			GPS Latitude/Longitude	
				Start	End
Item	Encroachments			38.507155 °	38.509035 °
				-121.682817 °	-121.663488 °
DWR ID	DWR_ST0007_02_s_2012_3				
Comment Code					
DT : Ditch					
Inspector Comment					
This ditch is within the 10-easement

Levee mile 0.18 looking upstream from the landside slope, irrigation ditch along the toe.

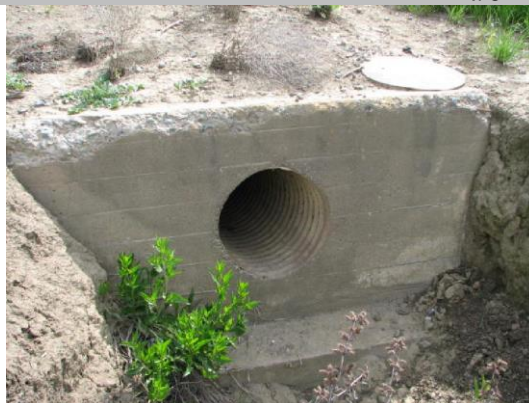
Photo 1 of 3 : UCIP_SP_2017_33410_60496.jpg

LM Start	0.18	Rating **	A/W	Issue No.	49
LM End	0.18	Issue Type +	Ma	Location *	WS
Category	Supplemental			GPS Latitude/Longitude	
				Start	End
Item	DWR UCIP LMA Responsibility			38.507320 °	38.507320 °
				-121.662799 °	-121.662799 °
DWR ID					
Comment Code					
Inspector Comment					
FS_ID:33410 DS_ID:16631 EP_NO: 10275 Repair Type: No Action Needed Crossing Status: Found UCIP Comments: FIELD_STRUCT_DESC: 24-inch pipe through the levee 11.0 feet below the crown. Slide gate on waterward end. (ABO No. 10275 - Pereira) Included in O+M Manual FS Date: 4/10/2014 2:50:16 PM

L/S headwall and pipe

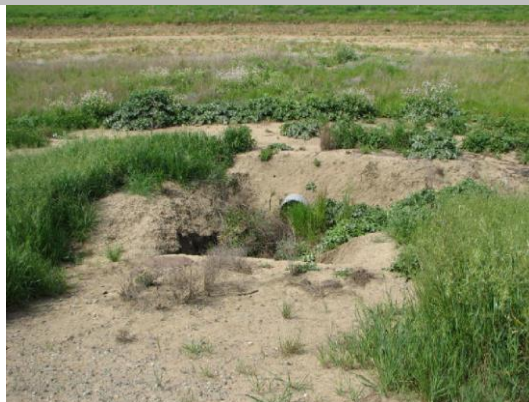
Photo 2 of 3 : UCIP_SP_2017_33410_60498.jpg

LM Start	0.18	Rating **	A/W	Issue No.	49 (cont)
LM End	0.18	Issue Type +	Ma	Location *	WS

L/S headwall at pipe

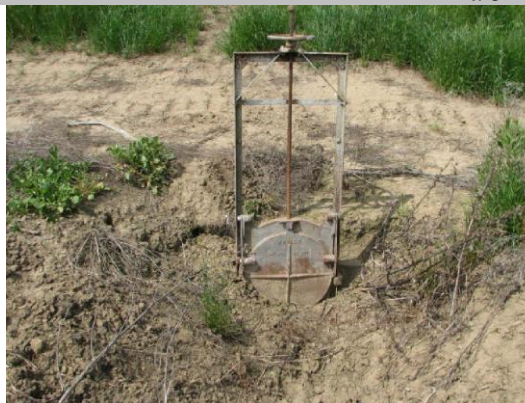
Photo 3 of 3 : UCIP_SP_2017_33410_60497.jpg

LM Start	0.18	Rating **	A/W	Issue No.	49 (cont)
LM End	0.18	Issue Type +	Ma	Location *	WS
Category	Supplemental			GPS Latitude/Longitude	
				Start	End
Item	DWR UCIP LMA Responsibility			38.507320 °	38.507320 °
				-121.662799 °	-121.662799 °
DWR ID					
Comment Code					
Inspector Comment					
FS_ID:33410 DS_ID:16631 EP_NO: 10275 Repair Type: No Action Needed Crossing Status: Found UCIP Comments: FIELD_STRUCT_DESC: 24-inch pipe through the levee 11.0 feet below the crown. Slide gate on waterward end. (ABO No. 10275 - Pereira) Included in O+M Manual FS Date: 4/10/2014 2:50:16 PM

W/S slide gate

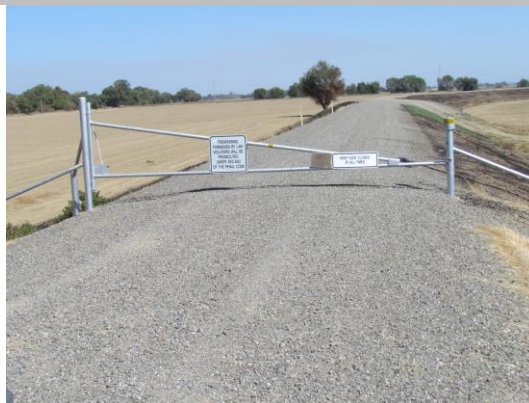
Photo 1 of 3 : SP_2017_ST0007_283_29_20170404_00005.jpg

LM Start	0.55	Rating **	U	Issue No.	29
LM End	0.55	Issue Type +	En	Location *	LS
Category	Earthen Levee			GPS Latitude/Longitude	
				Start	End
Item	Encroachments			38.510249 °	38.510249 °
				-121.667551 °	-121.667551 °
DWR ID	DWR_ST0007_02_s_2013_29				
Comment Code					
FE : Fence					
Inspector Comment					
No CVFPB Permit for this crossing. The SMY levee maintenance Agency installed this fence a few years ago.

Levee mile 0.55 crown roadway crossing.

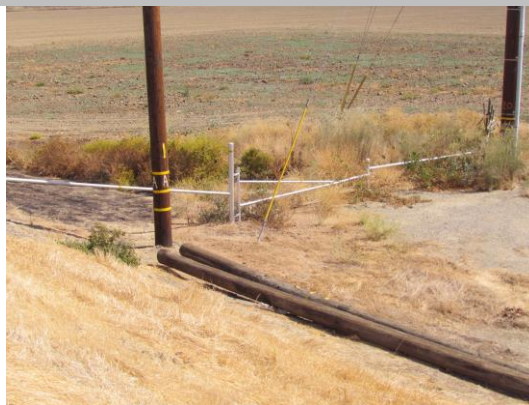
Photo 2 of 3 : SP_2017_ST0007_283_29_20170404_00006.jpg

Levee mile 0.55 landside slope and toe.

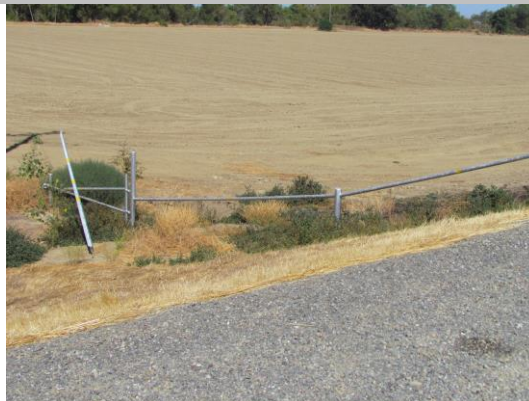
Photo 3 of 3 : SP_2017_ST0007_283_29_20170404_00007.jpg

Levee mile 0.55 waterside slope and toe.

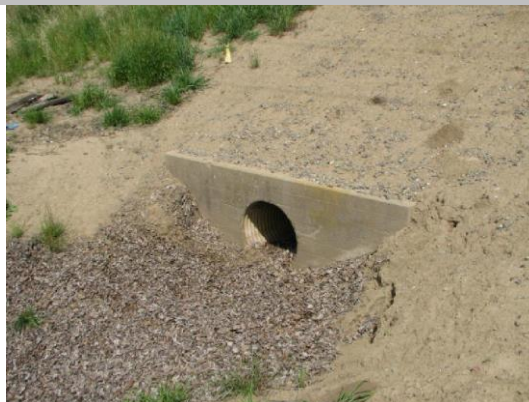
Photo 2 of 3 : UCIP_SP_2017_33407_60492.jpg

LM Start	0.82	Rating **	A/W	Issue No.	50 (cont)
LM End	0.82	Issue Type +	Ma	Location *	LS

L/S headwall

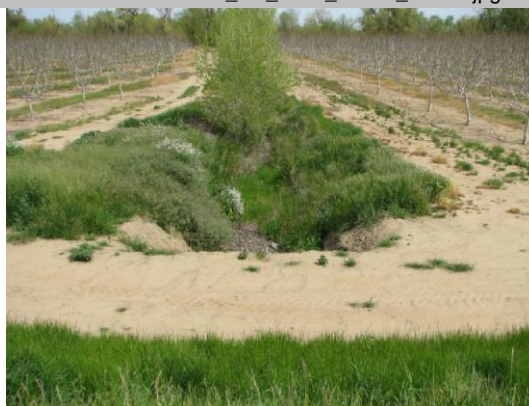
Photo 3 of 3 : UCIP_SP_2017_33407_60491.jpg

LM Start	0.82	Rating **	A/W	Issue No.	50 (cont)
LM End	0.82	Issue Type +	Ma	Location *	LS
Category	Supplemental			GPS Latitude/Longitude	
				Start	End
Item	DWR UCIP LMA Responsibility			38.510700 °	38.510700 °
				-121.672410 °	-121.672410 °
DWR ID					
Comment Code					
Inspector Comment					
FS_ID:33407 DS_ID:16621 EP_NO: 10270 Repair Type: No Action Needed Crossing Status: Found UCIP Comments: FIELD_STRUCT_DESC: 36-inch pipe through the levee 14.0 feet below the crown. Flap gate on waterward end. Concrete headwall on landward end. (ABO No. 10270 - Hamel) FS Date: 4/10/2014 2:49:39 PM

W/S Channel

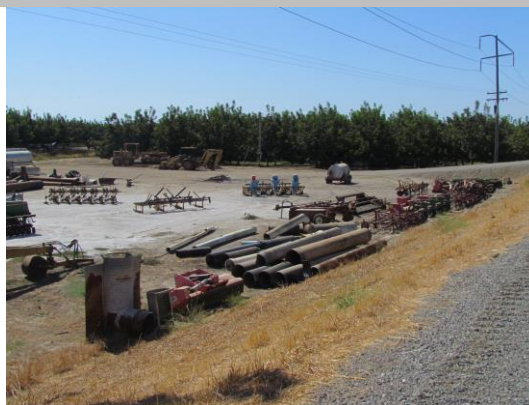
Photo 1 of 1 : SP_2017_ST0007_283_23_20170404_00004.jpg

LM Start	1.01	Rating **	M	Issue No.	23
LM End	1.05	Issue Type +	En	Location *	LS
Category	Earthen Levee			GPS Latitude/Longitude	
				Start	End
Item	Encroachments			38.511402 °	38.511598 °
				-121.675727 °	-121.676413 °
DWR ID	DWR_ST0007_02_f_2016_23				
Comment Code					
EQ : Equipment					
Inspector Comment					
This equipment and materials can be moved back away from the easement.

Levee mile 1.01 landside toe looking upstream.

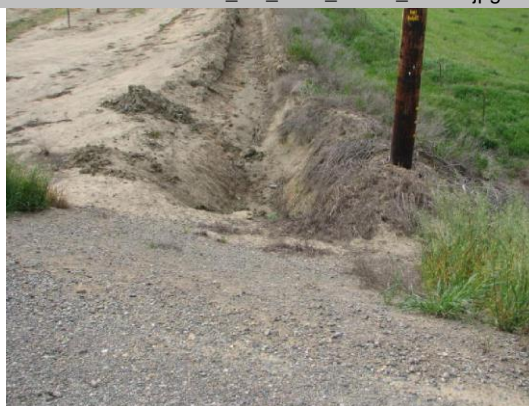
Photo 1 of 3 : UCIP_SP_2017_33401_60475.jpg

LM Start	1.59	Rating **	A/W	Issue No.	51
LM End	1.59	Issue Type +	Ma	Location *	LS
Category	Supplemental			GPS Latitude/Longitude	
				Start	End
Item	DWR UCIP LMA Responsibility			38.514220 °	38.514220 °
				-121.685880 °	-121.685880 °
DWR ID					
Comment Code					
Inspector Comment					
FS_ID:33401 DS_ID:16622 EP_NO: 10270 Repair Type: No Action Needed Crossing Status: Found UCIP Comments: FIELD_STRUCT_DESC: 24-inch pipe through the levee 16.0 feet below the crown. Slide gate on waterward slope. Concrete headwall on both ends. (ABO No. 10270 - Hamel) FS Date: 4/10/2014 2:48:13 PM

LS channel

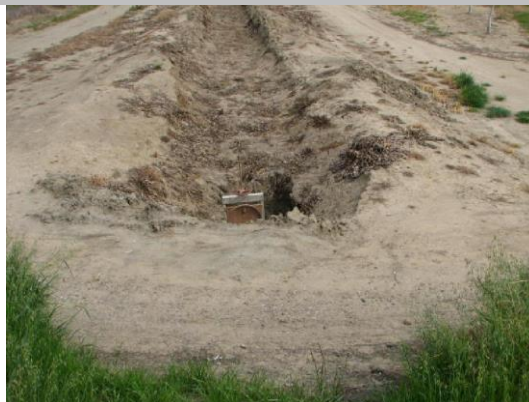
Photo 2 of 3 : UCIP_SP_2017_33401_60478.jpg

LM Start	1.59	Rating **	A/W	Issue No.	51 (cont)
LM End	1.59	Issue Type +	Ma	Location *	LS

WS Channel and Slide gate

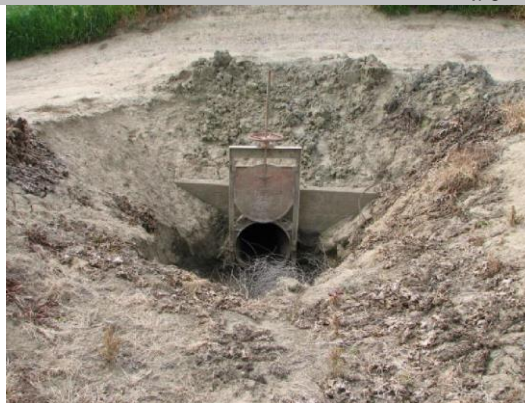
Photo 3 of 3 : UCIP_SP_2017_33401_60477.jpg

LM Start	1.59	Rating **	A/W	Issue No.	51 (cont)
LM End	1.59	Issue Type +	Ma	Location *	LS
Category	Supplemental			GPS Latitude/Longitude	
				Start	End
Item	DWR UCIP LMA Responsibility			38.514220 °	38.514220 °
				-121.685880 °	-121.685880 °
DWR ID					
Comment Code					
Inspector Comment					
FS_ID:33401 DS_ID:16622 EP_NO: 10270 Repair Type: No Action Needed Crossing Status: Found UCIP Comments: FIELD_STRUCT_DESC: 24-inch pipe through the levee 16.0 feet below the crown. Slide gate on waterward slope. Concrete headwall on both ends. (ABO No. 10270 - Hamel) FS Date: 4/10/2014 2:48:13 PM

WS slide gate

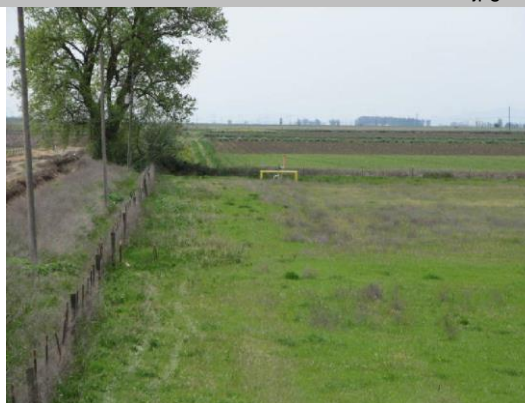
Photo 1 of 3 : UCIP_SP_2017_33400_60474.jpg

LM Start	1.60	Rating **	M	Issue No.	52
LM End	1.60	Issue Type +	En	Location *	LS
Category	Supplemental			GPS Latitude/Longitude	
				Start	End
Item	DWR UCIP Field Study			38.514250 °	38.514250 °
				-121.685980 °	-121.685980 °
DWR ID					
Comment Code					
Inspector Comment					
FS_ID:33400					
DS_ID:16623					
EP_NO: 9139					
Repair Type: Non-Urgent					
Crossing Status: Indicator Found					
UCIP Comments: There are no appropriate gas markers present on levee to indicate pipe location. Markers need to be installed. No danger to the levee					
FIELD_STRUCT_DESC: 8-inch gas line through the levee 3.0 feet below crown under channel and through Unit No. 1 levee. (Permit No. 9139 - DOW)					
FS Date: 4/10/2014 2:45:48 PM

Gas vent 800-feet to south

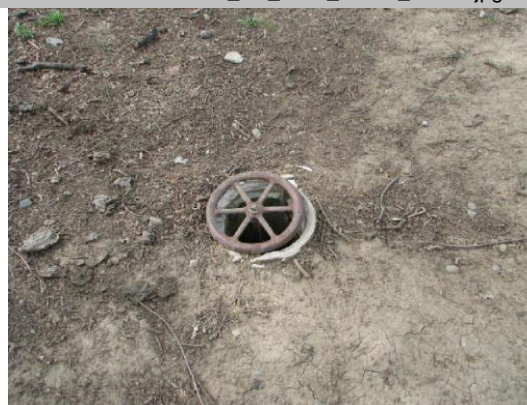
Photo 1 of 3 : UCIP_SP_2017_41072_60468.jpg

LM Start	2.09	Rating **	M	Issue No.	53
LM End	2.09	Issue Type +	En	Location *	LS
Category	Supplemental			GPS Latitude/Longitude	
				Start	End
Item	DWR UCIP Field Study			38.515440 °	38.515440 °
				-121.694920 °	-121.694920 °
DWR ID					
Comment Code					
Inspector Comment					
FS_ID:41072 DS_ID:16624 EP_NO: 10268 Repair Type: Non-Urgent Crossing Status: Found UCIP Comments: It is apparent that there is an irrigation pipe sleeved through the 25-inch pipe, but size cannot be determined. FIELD_STRUCT_DESC: 24-inch irrigation pipe through the levee 13.0 feet below the crown. Gate valve on landward side in 10-inch concrete standpipe. 36-inch standpipe on WS toe. Headwall on LS toe. (ABO No. 10268 - DOW). FS Date: 4/10/2014 2:45:00 PM

gate valve on LS toe in 10-inch standpipe

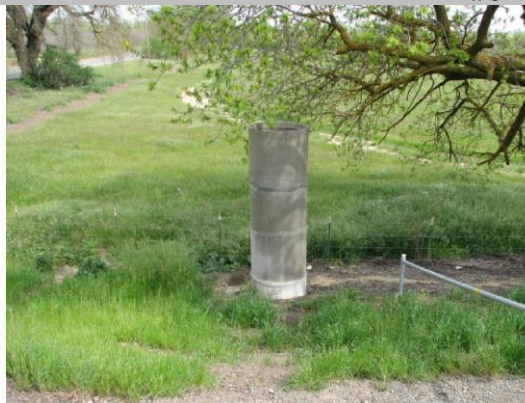
Photo 2 of 3 : UCIP_SP_2017_41072_60471.jpg

LM Start	2.09	Rating **	M	Issue No.	53 (cont)	
LM End	2.09	Issue Type +	En	Location *	LS	
Category	Supplemental			GPS Latitude/Longitude		
				Start	End	
Item	DWR UCIP Field Study			38.515440 °	38.515440 °	
				-121.694920 °	-121.694920 °	
DWR ID						
Comment Code						
Inspector Comment						
FS_ID:41072						
DS_ID:16624						
EP_NO: 10268						
Repair Type: Non-Urgent						
Crossing Status: Found						
UCIP Comments: It is apparent that there is an irrigation pipe sleeved through the 25-inch pipe, but size cannot be determined.						
FIELD_STRUCT_DESC: 24-inch irrigation pipe through the levee 13.0 feet below the crown. Gate valve on landward side in 10-inch concrete standpipe. 36-inch standpipe on WS toe. Headwall on LS toe. (ABO No. 10268 - DOW).						
FS Date: 4/10/2014 2:45:00 PM

36-inch standpipe WS toe

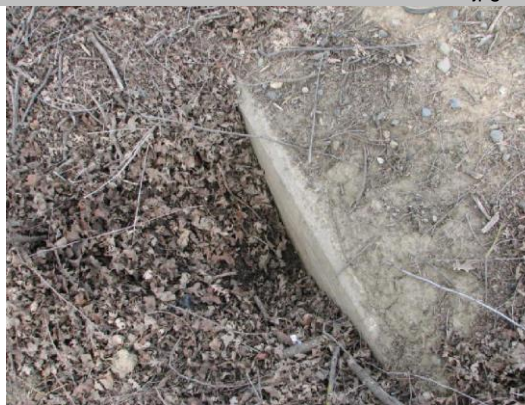
Photo 3 of 3 : UCIP_SP_2017_41072_60470.jpg

LM Start	2.09	Rating **	M	Issue No.	53 (cont)
LM End	2.09	Issue Type +	En	Location *	LS

LS headwall.

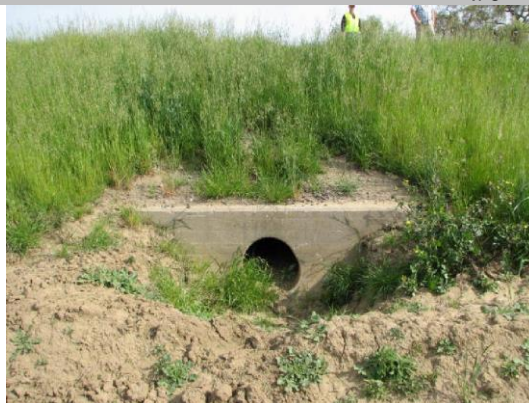
Photo 1 of 2 : UCIP_SP_2017_33395_60460.jpg

LM Start	2.65	Rating **	A/W	Issue No.	54
LM End	2.65	Issue Type +	Ma	Location *	LS
Category	Supplemental			GPS Latitude/Longitude	
				Start	End
Item	DWR UCIP LMA Responsibility			38.514865 °	38.514865 °
				-121.703839 °	-121.703839 °
DWR ID					
Comment Code					
Inspector Comment					
FS_ID:33395 DS_ID:16625 EP_NO: 10277 Repair Type: No Action Needed Crossing Status: Found UCIP Comments: FIELD_STRUCT_DESC: 24-inch drainpipe through the levee 9.0 feet below the crown. Slide gate on waterward slope. Concrete headwall on both ends. (ABO No. 10277 - Schoeningh) FS Date: 4/10/2014 2:43:57 PM

LS headwall

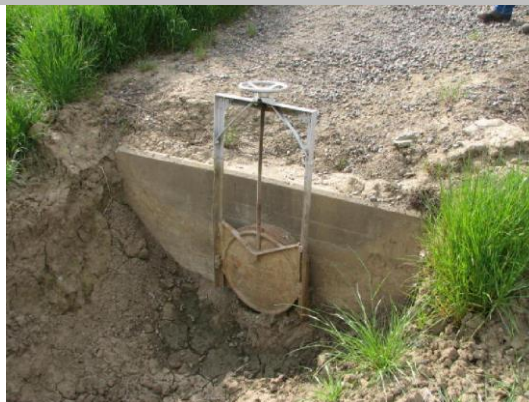
Photo 2 of 2 : UCIP_SP_2017_33395_60459.jpg

LM Start	2.65	Rating **	A/W	Issue No.	54 (cont)
LM End	2.65	Issue Type +	Ma	Location *	LS

WS headwall and slidegate

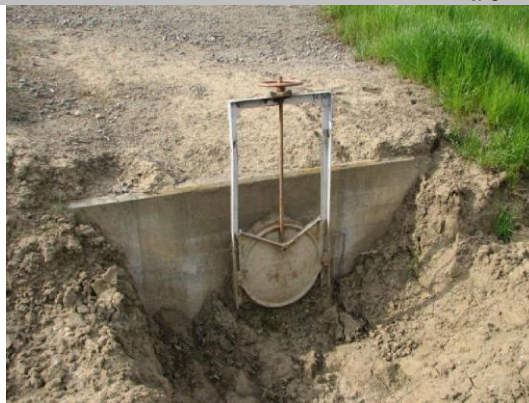
Photo 1 of 2 : UCIP_SP_2017_33393_60456.jpg

LM Start	3.04	Rating **	A/W	Issue No.	55
LM End	3.04	Issue Type +	Ma	Location *	LS
Category	Supplemental			GPS Latitude/Longitude	
				Start	End
Item	DWR UCIP LMA Responsibility			38.515080 °	38.515080 °
				-121.711050 °	-121.711050 °
DWR ID					
Comment Code					
Inspector Comment					
FS_ID:33393 DS_ID:16626 EP_NO: 10277 Repair Type: No Action Needed Crossing Status: Found UCIP Comments: FIELD_STRUCT_DESC: 24-inch pipe through the levee 9.0 feet below the crown. Slide gate on waterward slope and headwalls on both sides. (ABO No. 10277 - Schoeningh) FS Date: 4/10/2014 2:43:31 PM

WS headwall and slide gate

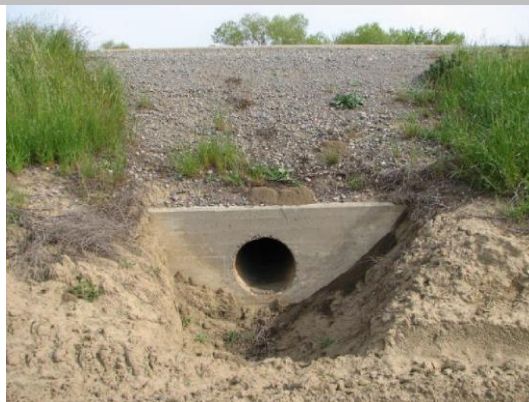
Photo 2 of 2 : UCIP_SP_2017_33393_60455.jpg

LM Start	3.04	Rating **	A/W	Issue No.	55 (cont)
LM End	3.04	Issue Type +	Ma	Location *	LS

LS headwall and pipe

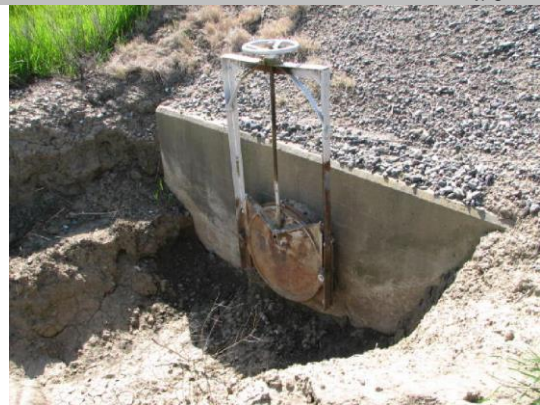
Photo 1 of 2 : UCIP_SP_2017_33380_60438.jpg

LM Start	3.93	Rating **	A/W	Issue No.	57
LM End	3.93	Issue Type +	Ma	Location *	LS
Category	Supplemental			GPS Latitude/Longitude	
				Start	End
Item	DWR UCIP LMA Responsibility			38.515620 °	38.515620 °
				-121.727540 °	-121.727540 °
DWR ID					
Comment Code					
Inspector Comment					
FS_ID:33380 DS_ID:16628 EP_NO: 10269 Repair Type: No Action Needed Crossing Status: Found UCIP Comments: FIELD_STRUCT_DESC: 24-inch pipe through the levee 12.0 feet below the crown. Slide gate on waterward end. Concrete headwall on both ends. (ABO No. 10269 - Fahn) FS Date: 4/10/2014 2:40:00 PM

WS headwall and slide gate

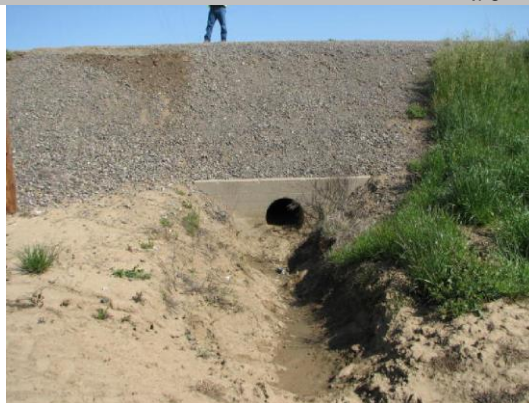
Photo 2 of 2 : UCIP_SP_2017_33380_60437.jpg

LM Start	3.93	Rating **	A/W	Issue No.	57 (cont)
LM End	3.93	Issue Type +	Ma	Location *	LS
Category	Supplemental			GPS Latitude/Longitude	
				Start	End
Item	DWR UCIP LMA Responsibility			38.515620 °	38.515620 °
				-121.727540 °	-121.727540 °
DWR ID					
Comment Code					
Inspector Comment					
FS_ID:33380 DS_ID:16628 EP_NO: 10269 Repair Type: No Action Needed Crossing Status: Found UCIP Comments: FIELD_STRUCT_DESC: 24-inch pipe through the levee 12.0 feet below the crown. Slide gate on waterward end. Concrete headwall on both ends. (ABO No. 10269 - Fahn) FS Date: 4/10/2014 2:40:00 PM

LS headwall

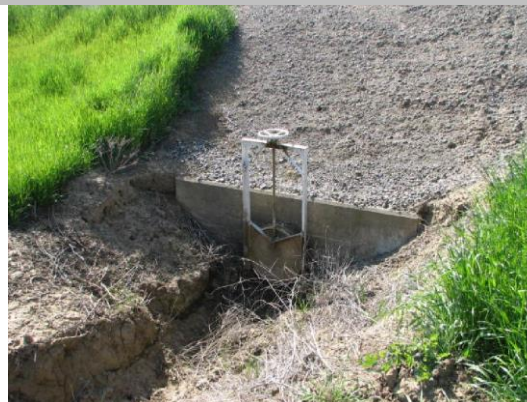
Photo 2 of 2 : UCIP_SP_2017_33378_60434.jpg

LM Start	4.17	Rating **	A/W	Issue No.	58 (cont)
LM End	4.17	Issue Type +	Ma	Location *	WS

WS slide gate and headwall

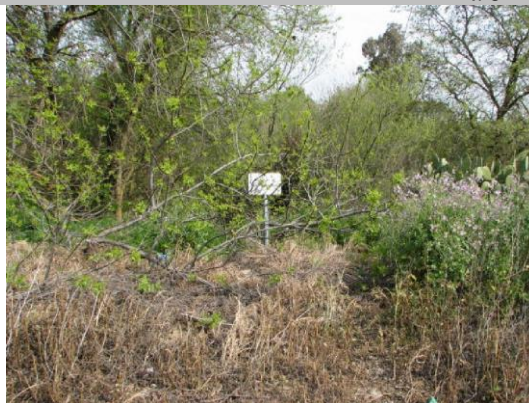
Photo 1 of 2 : UCIP_SP_2017_33377_60433.jpg

LM Start	4.17	Rating **	M	Issue No.	59
LM End	4.17	Issue Type +	En	Location *	WS
Category	Supplemental			GPS Latitude/Longitude	
				Start	End
Item	DWR UCIP Field Study			38.515780 °	38.515780 °
				-121.731950 °	-121.731950 °
DWR ID					
Comment Code					
Inspector Comment					
FS_ID:33377					
DS_ID:16630					
EP_NO: 10820					
Repair Type: Non-Urgent					
Crossing Status: Indicator Found					
UCIP Comments: Signs for pipeline need to be updated to state Gas line. Current markers are insufficient.					
FIELD_STRUCT_DESC: 4-inch natural gas pipeline across the channel and levees of Putah Creek approximately 1/2 mile downstream from Davis Road. Installed 2 feet below crown. (Permit No. 10820)					
FS Date: 4/10/2014 2:39:19 PM

WS marker 320 feet north of levee at stream bank.

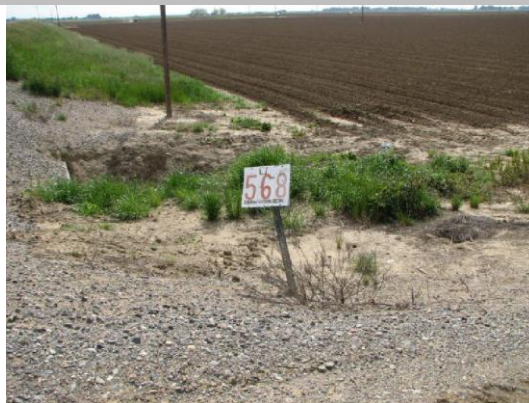
Photo 2 of 2 : UCIP_SP_2017_33377_60432.jpg

LS marker on east side of access ramp.

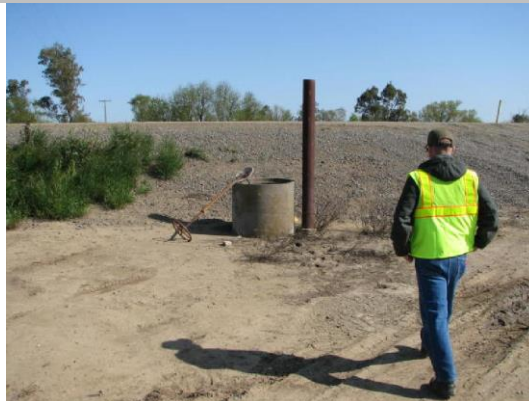
Photo 1 of 3 : UCIP_SP_2017_33375_60427.jpg

LM Start	4.66	Rating **	A/W	Issue No.	60
LM End	4.66	Issue Type +	Ma	Location *	WS
Category	Supplemental			GPS Latitude/Longitude	
				Start	End
Item	DWR UCIP LMA Responsibility			38.515814 °	38.515814 °
				-121.741030 °	-121.741030 °
DWR ID					
Comment Code					
Inspector Comment					
FS_ID:33375 DS_ID:16644 EP_NO: 10271 Repair Type: No Action Needed Crossing Status: Found UCIP Comments: FIELD_STRUCT_DESC: 24-inch drain pipe through the levee 9.5 feet below the crown. Flap gate on W/S, 36-inch standpipe on L/S. FS Date: 4/10/2014 2:38:34 PM

LS 36-inch standpipe

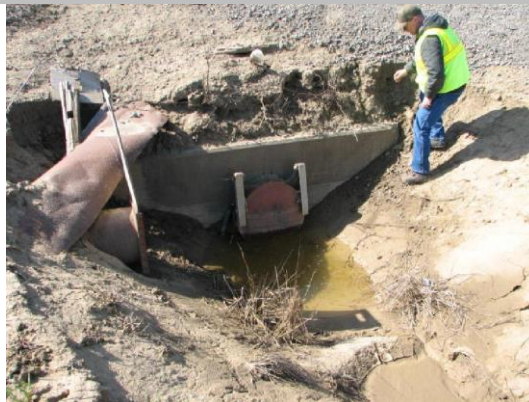
Photo 2 of 3 : UCIP_SP_2017_33375_60429.jpg

WS headwall and flapgate.

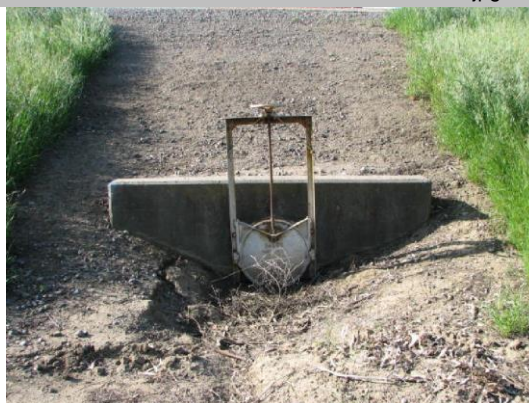
Photo 3 of 3 : UCIP_SP_2017_33369_60412.jpg

W/S positive closure device

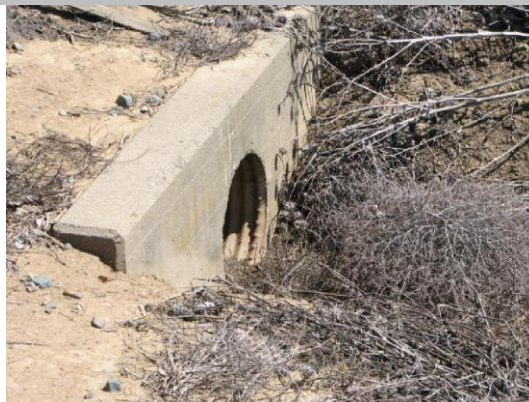
Photo 2 of 2 : UCIP_SP_2017_42953_60396.jpg

LM Start	5.84	Rating **	A/W	Issue No.	67
LM End	5.84	Issue Type +	Ma	Location *	LS
Category	Supplemental			GPS Latitude/Longitude	
				Start	End
Item	DWR UCIP LMA Responsibility			38.516290°	38.516290°
				-121.762280°	-121.762280°
DWR ID					
Comment Code					
Inspector Comment					
FS_ID:42953 DS_ID:16639 EP_NO: 10278 Repair Type: No Action Needed Crossing Status: Found UCIP Comments: All material was removed FIELD_STRUCT_DESC: 24-inch drainpipe through levee 15.0 feet below crown. Flap gate on waterward end headwall on LS. (ABO No. 10278 - S.P.R.R.) FS Date: 4/10/2014 2:32:00 PM

LS headwall

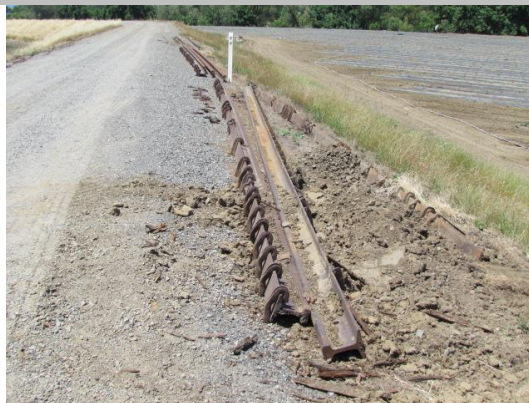
Photo 1 of 2 : SP_2017_ST0007_283_30_20170511_00065.jpg

Union Pacific Railroad has left on the waterside shoulder several track railings and metal ties.

LM Start	5.85	Rating **	U	Issue No.	30
LM End	5.87	Issue Type +	En	Location *	WS
Category	Earthen Levee			GPS Latitude/Longitude	
				Start	End
Item	Encroachments			38.516353 °	38.516463 °
				-121.762393 °	-121.762757 °
DWR ID	DWR_ST0007_02_s_2017_30				
Comment Code					
MA : Material					
Inspector Comment					
Union Pacific Rail road has been notified that they need to remove the materials left behind. 5-2017.

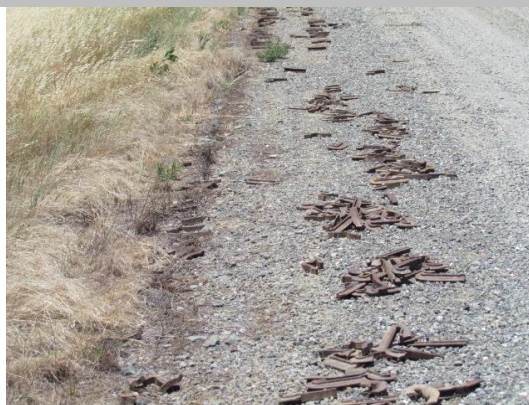
Photo 2 of 2 : SP_2017_ST0007_283_30_20170511_00066.jpg

On the landside same levee mile there are several metal track ties on the roadway.

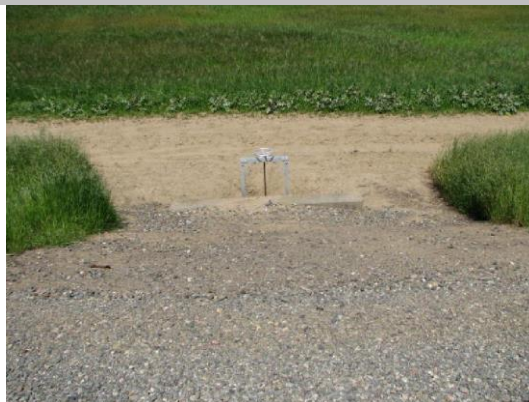
Photo 2 of 2 : UCIP_SP_2017_33353_60379.jpg

LM Start	6.02	Rating **	A/W	Issue No.	68
LM End	6.02	Issue Type +	Ma	Location *	WS
Category	Supplemental			GPS Latitude/Longitude	
				Start	End
Item	DWR UCIP LMA Responsibility			38.516658 °	38.516658 °
				-121.765572 °	-121.765572 °
DWR ID					
Comment Code					
Inspector Comment					
FS_ID:33353 DS_ID:16641 EP_NO: 10265 Repair Type: No Action Needed Crossing Status: Found UCIP Comments: Pipe has some sedimentation buildup internally. FIELD_STRUCT_DESC: 24-inch irrigation pipe through the levee, 11.0 feet below crown. Slide gate on waterward end. Concrete headwall on landward end. (ABO 10265) (Also included in ABO 11296.) FS Date: 4/10/2014 2:30:16 PM

WS slide gate

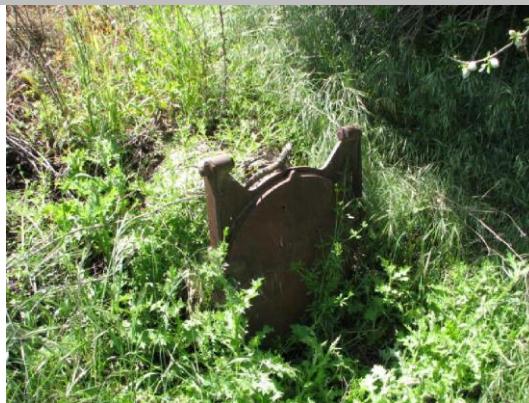
Photo 2 of 2 : UCIP_SP_2017_42959_60373.jpg

FS_ID:42959
DS_ID:16642
EP_NO: 10265
Repair Type: Non-Urgent
Crossing Status: Found
UCIP Comments: Debris buildup at WS outlet
FIELD_STRUCT_DESC: 30-inch pipe through the levee, 17.0 feet below the crown. Headwall and Slide gate on landward end. Flap gate on waterward end 120 feet to the north of crossing. ABO 10265. Also included in Permit No. 11296
FS Date: 4/10/2014 2:29:00 PM

WS flap gate

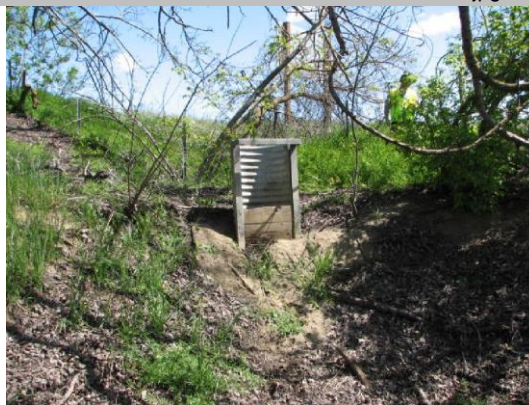
Photo 2 of 3 : UCIP_SP_2017_33348_60370.jpg

Weir inlet at pond on LS toe.

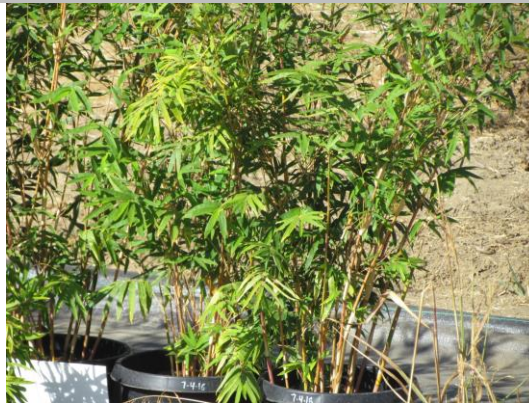
Photo 1 of 2 : SP_2017_ST0007_283_41_20170404_00010.jpg

LM Start	6.63	Rating **	U	Issue No.	41
LM End	6.74	Issue Type +	En	Location *	WS
Category	Earthen Levee			GPS Latitude/Longitude	
				Start	End
Item	Encroachments			38.519368 °	38.520210 °
				-121.775930 °	-121.777548 °
DWR ID	DWR_ST0007_02_s_2017_41				
Comment Code					
TR : Tree or limb					
Inspector Comment					
Bamboo being introduced by landowner on the waterside berm. This is unauthorized.

Putah Creek levee mile 6.63-6.74 unauthorized planting of arundo plants.

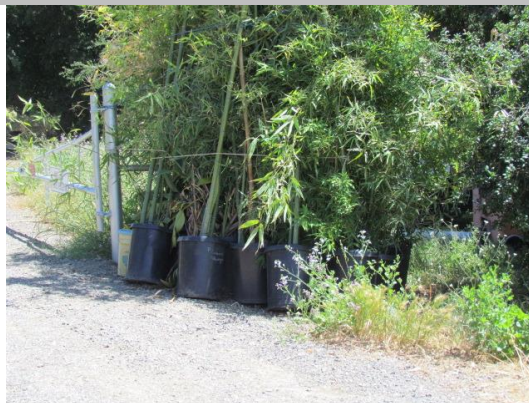
Photo 1 of 1 : SP_2017_ST0007_283_48_20170511_00063.jpg

Levee mile 6.70 at the District's gate landowner has placed several bamboo plantings against the gate way landward.

LM Start	6.70	Rating **	U	Issue No.	48
LM End	6.70	Issue Type +	En	Location *	CR
Category	Earthen Levee			GPS Latitude/Longitude	
				Start	End
Item	Encroachments			38.519927 °	38.519927 °
				-121.777033 °	-121.777033 °
DWR ID	DWR_ST0007_02_s_2017_48				
Comment Code					
TR : Tree or limb					
Inspector Comment					
Remove the unauthorized bamboo plantings from the landside levee section.

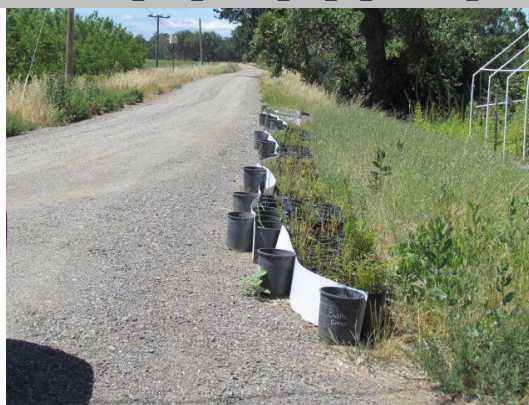
Photo 1 of 1 : SP_2017_ST0007_283_45_20170511_00062.jpg

Landowner has stored these bamboo plants on the waterside shoulder. And on parts of the roadway.

LM Start	6.71	Rating **	U	Issue No.	45
LM End	6.73	Issue Type +	En	Location *	WS
Category	Earthen Levee			GPS Latitude/Longitude	
				Start	End
Item	Encroachments			38.519948 °	38.520120 °
				-121.777163 °	-121.777405 °
DWR ID	DWR_ST0007_02_s_2017_45				
Comment Code					
CR : Crops					
Inspector Comment					
These plants need to be removed from the roadway and levee section.
